# Owens Enterprises

## Home Inspection Report

**123 Example Ln**

Inspected on Sat, Mar 3 2018 at 2:27 PM

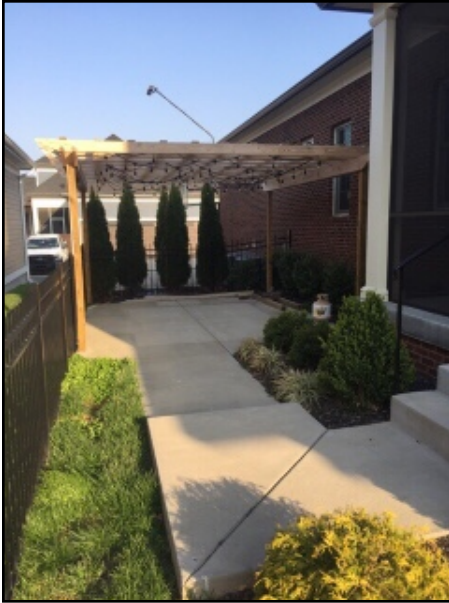
Figure 1-1

Comment 1:  
Patio and pergola are in acceptable condition. Keep pergola maintained.

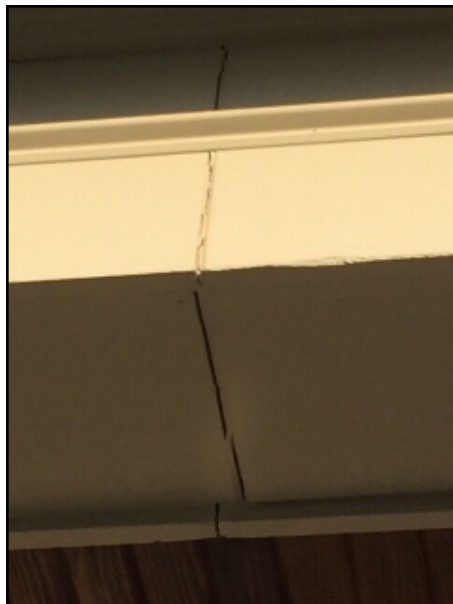
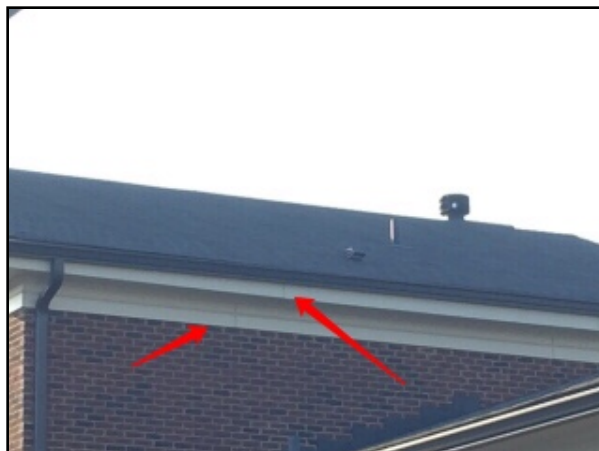
Several areas of gaps in exterior trim. Have caulked and painted to protect from weather.

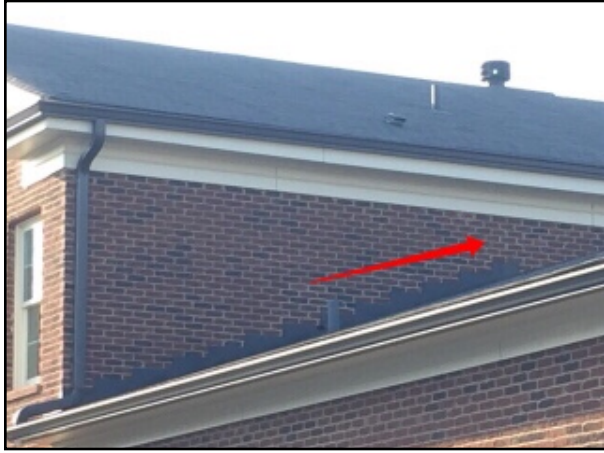
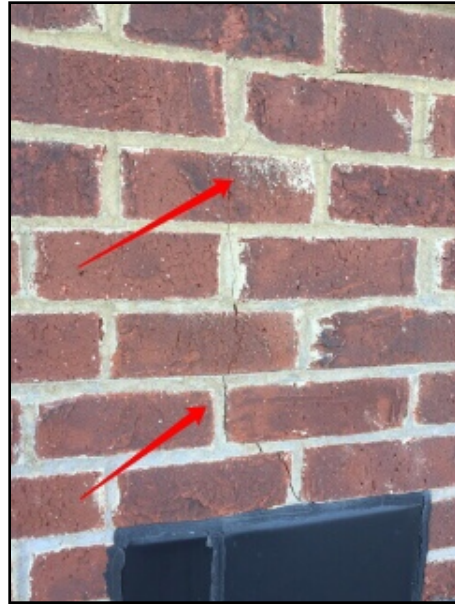
There are hairline brick cracks above rear roof. This is not a structural issue. Monitor and repair by tuck pointing if needed.

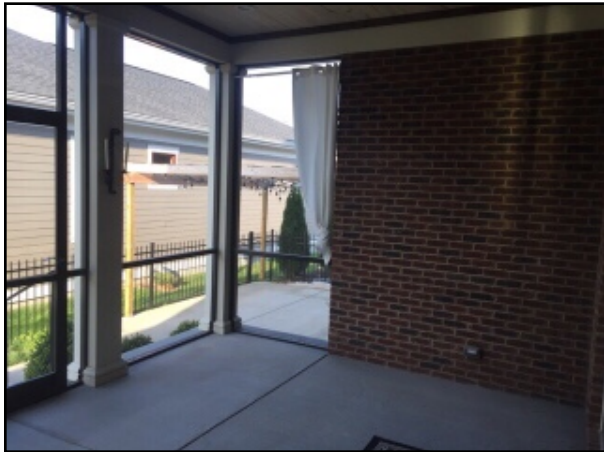
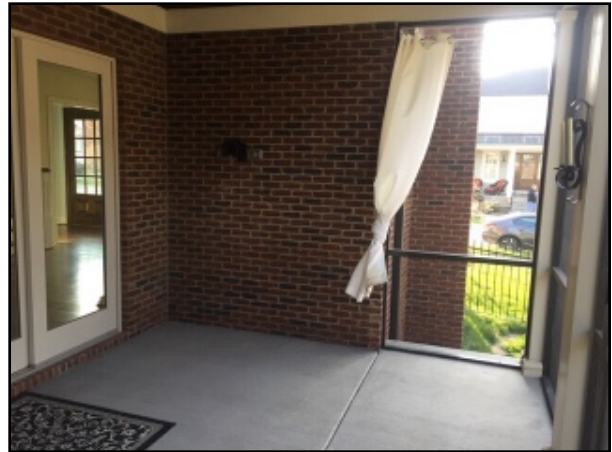
Comment 4:  
Screen porch is in acceptable condition. Ok.

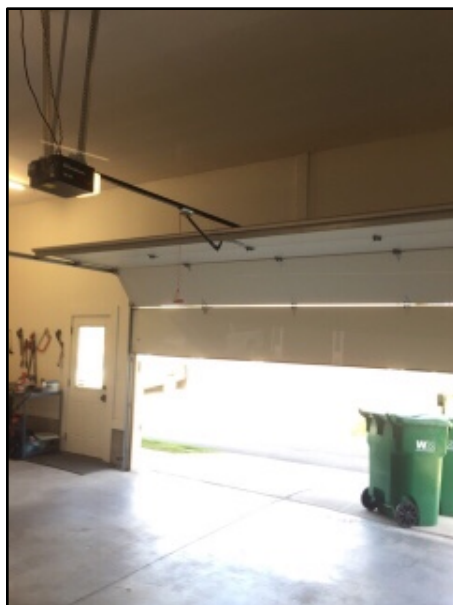
Figure 5-1

Comment 5:  
Vehicle door and opener operates as expected.

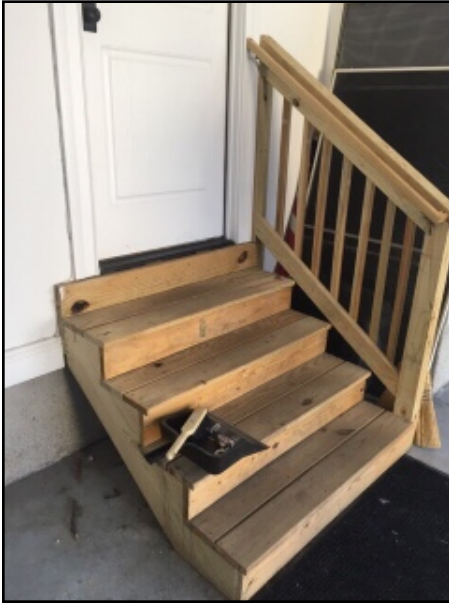
Figure 6-1

Steps in garage are missing handrail &amp; guardrail. Install for safety.

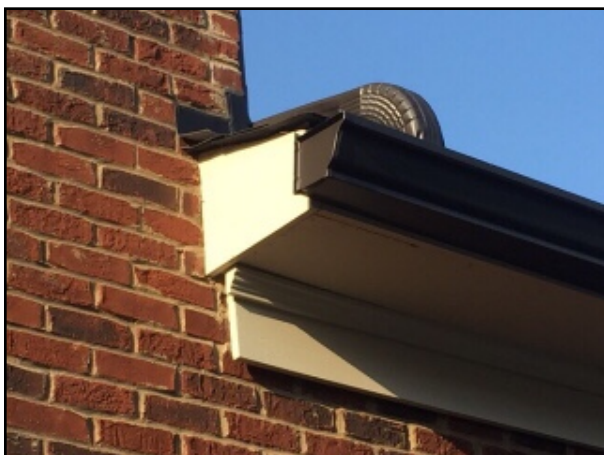
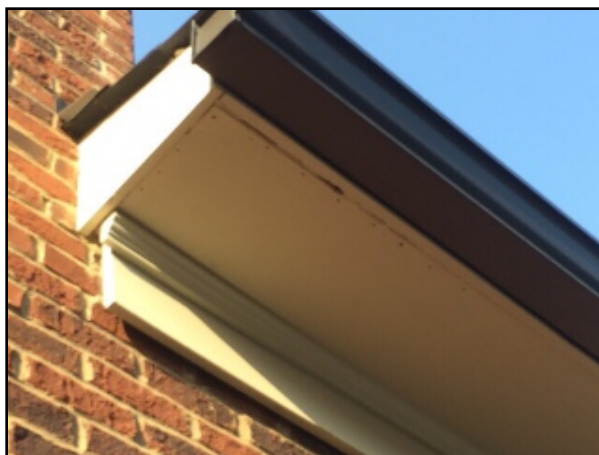
Prior repairs to rear right soffit. Have owner explain when and why repairs were made. Monitor.

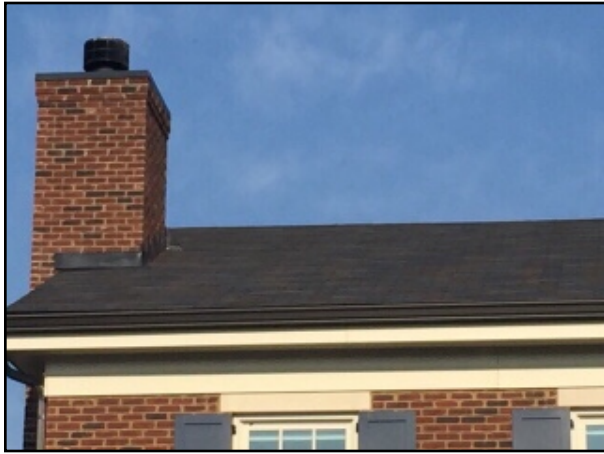
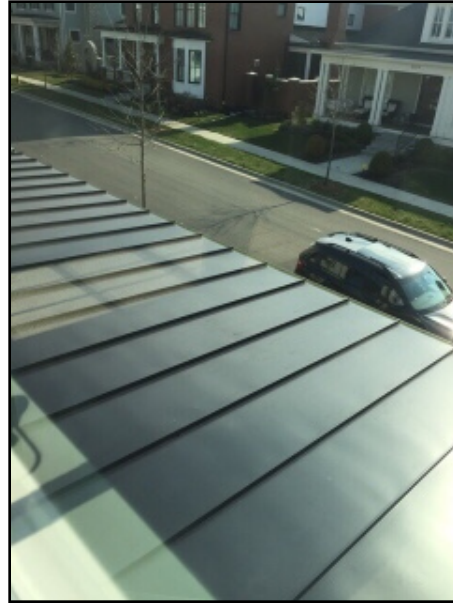
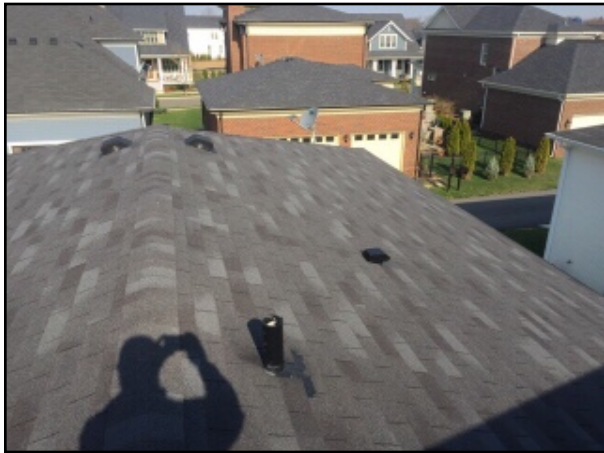
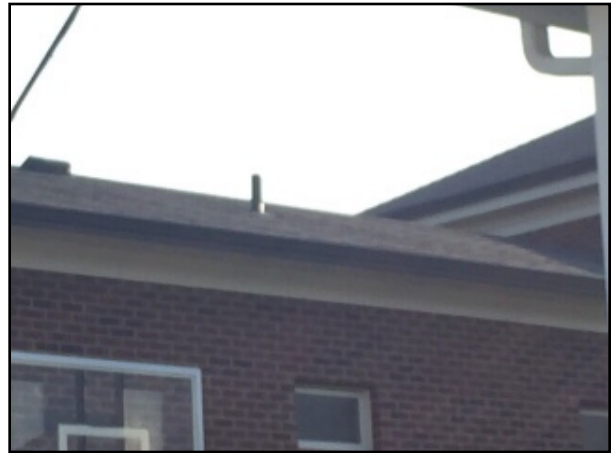
Visible roofing and gutters are in acceptable condition unless otherwise noted.

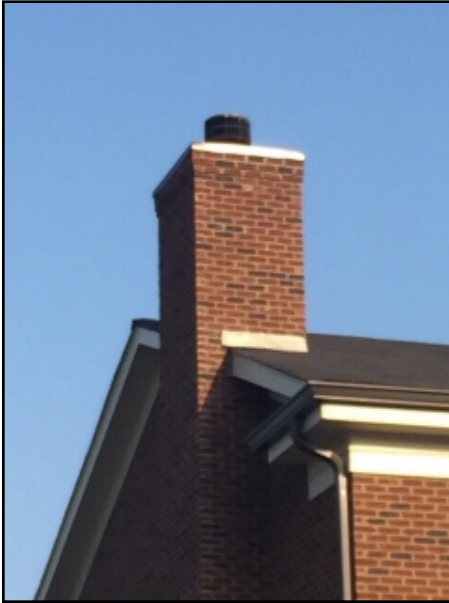
Figure 9-1

Comment 9:  
Chimney is in acceptable condition. Ok.

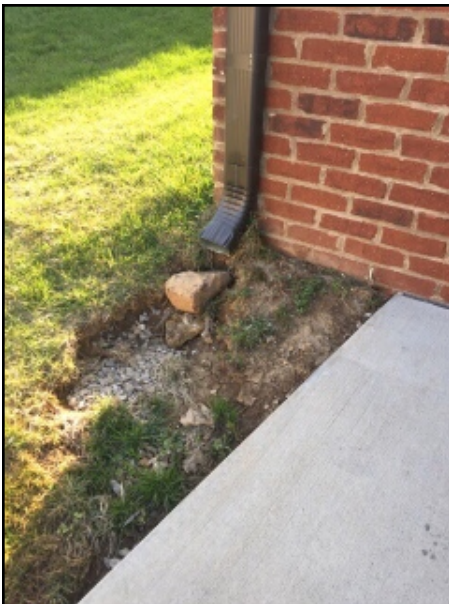
Figure 10-1

Comment 10:  
Rear garage downspout washing out soil. Install splash block and monitor.

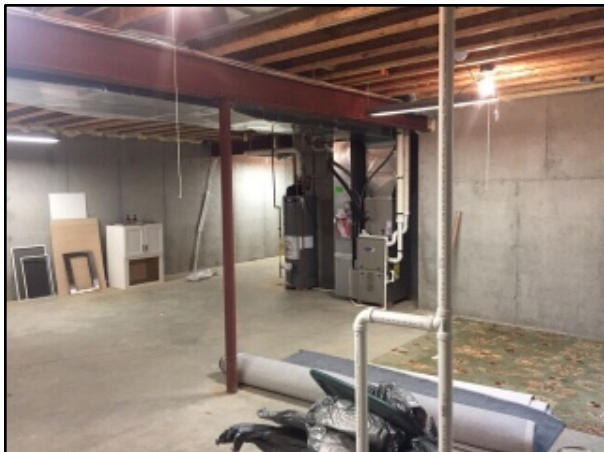
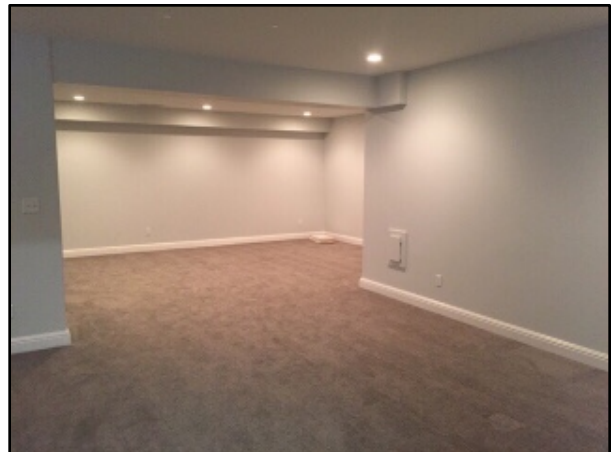
Majority of basement is finished with paneling, drywall and/or carpet. Very little of foundation is visible to inspect.

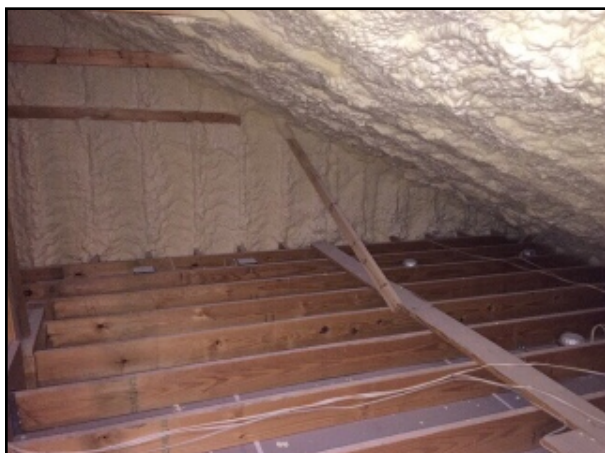
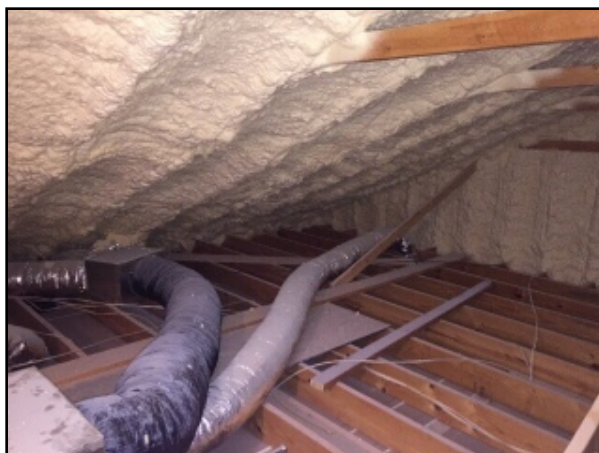
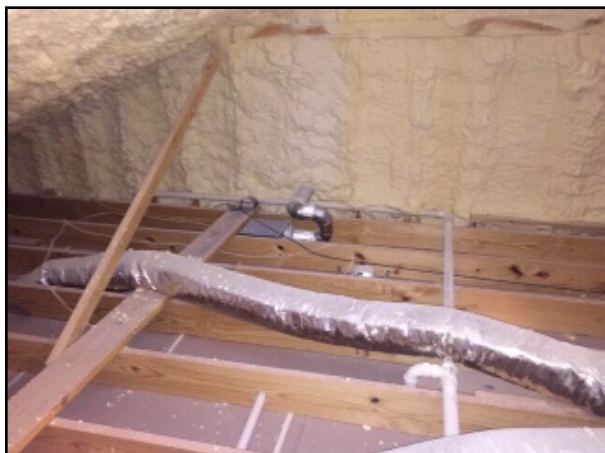
View inside attic. Ok. Most of roof structure was covered with insulation and was not visible.

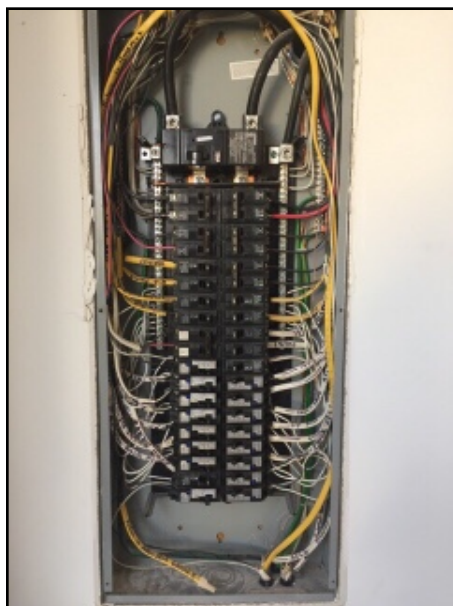
Figure 13-1

Comment 13:  
Inside electrical panel. Ok

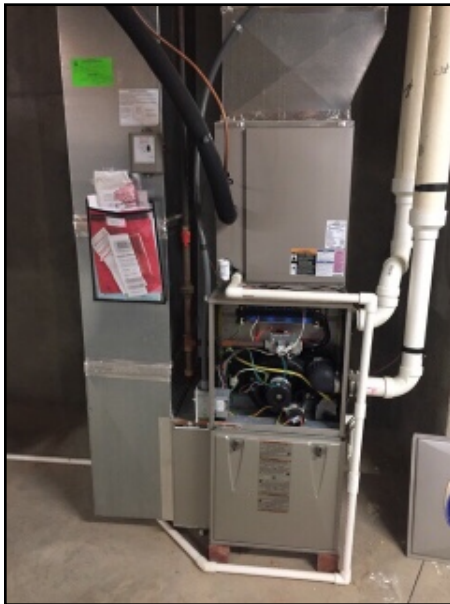
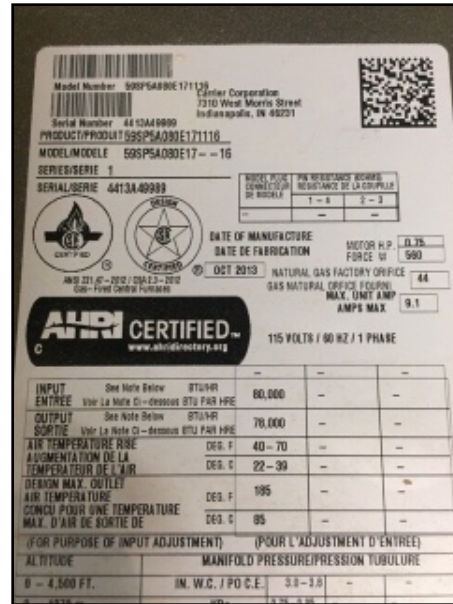
**Comment 14:**  
Furnace and data plate. Operates as expected.

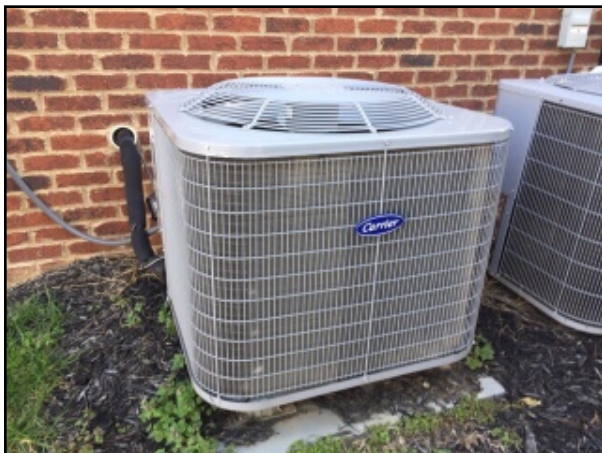
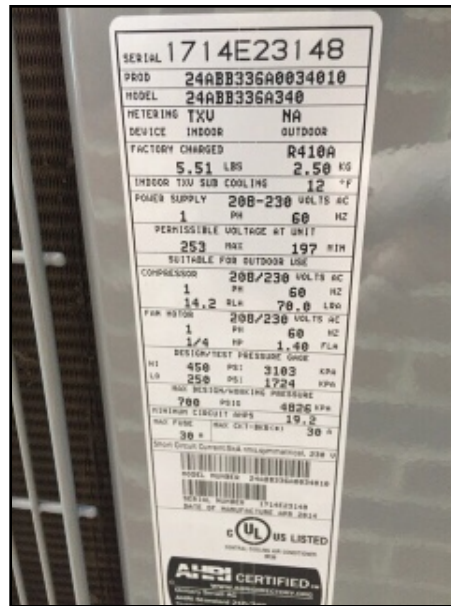
**Comment 15:**  
AC unit and data plate for basement unit. Operates as expected.

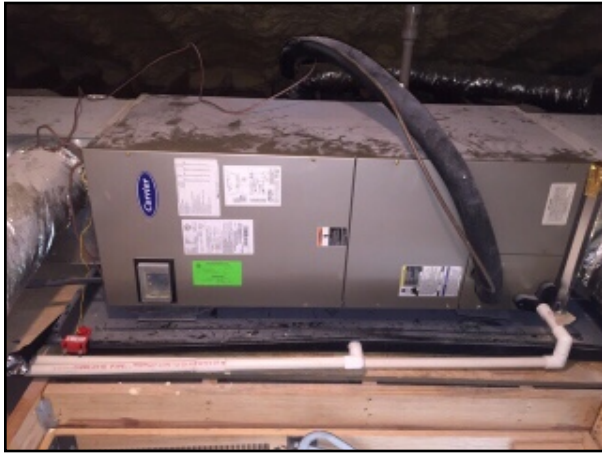
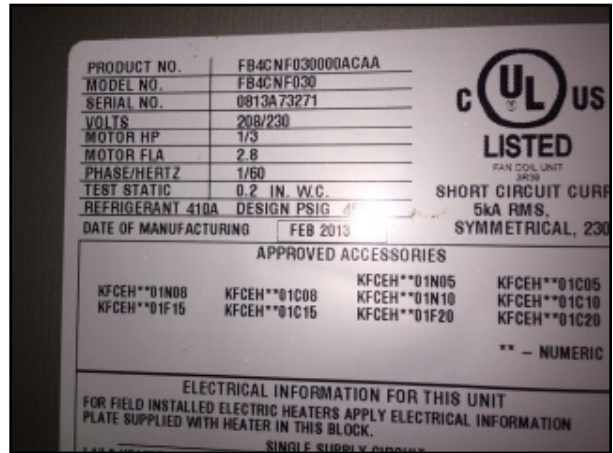
Heat pump and data plate. Operates as expected.

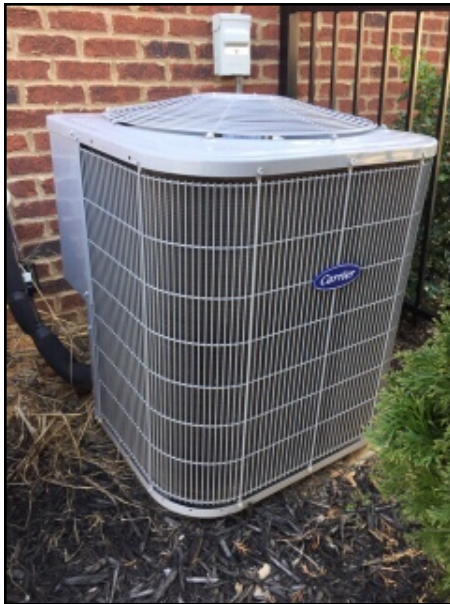
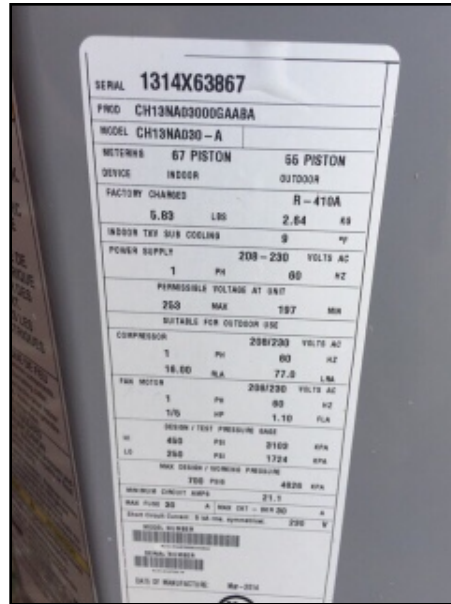
Heat pump and data plate for second floor. Operates as expected.

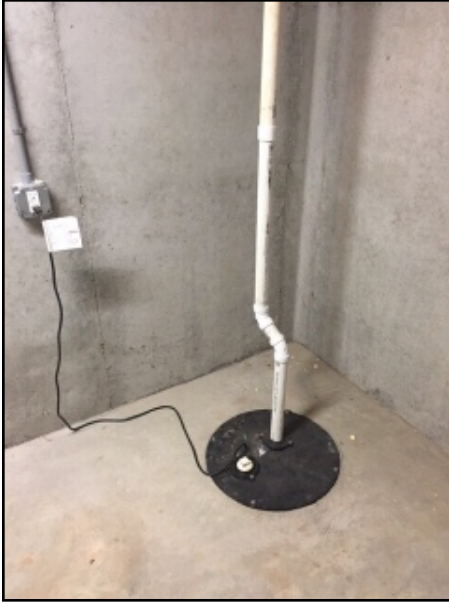
Figure 18-1

Sealed sump pump is present. Unable to operate in order to inspect.

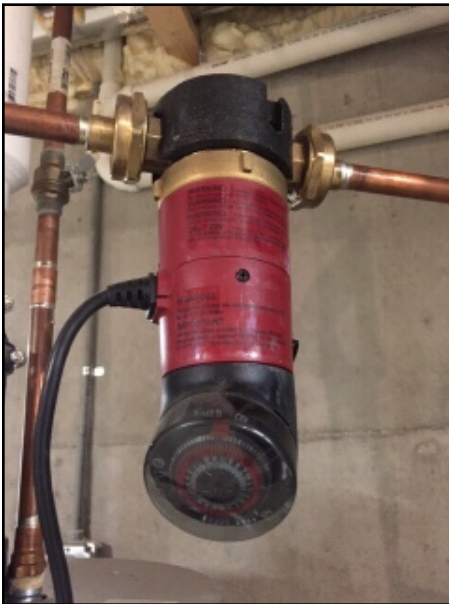
Figure 19-1

Comment 19:  
Hot water circulation pump installed. Appears to operate as expected.

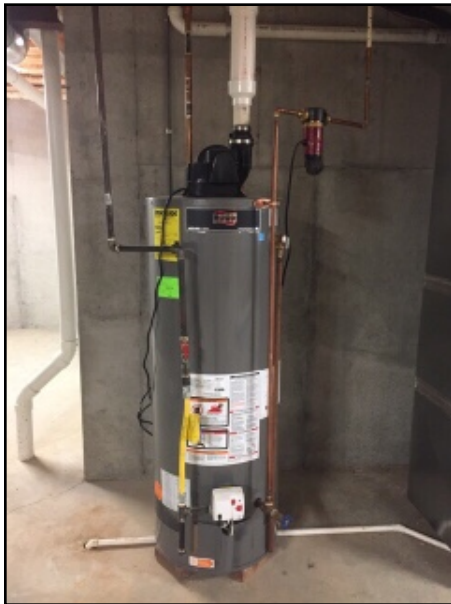
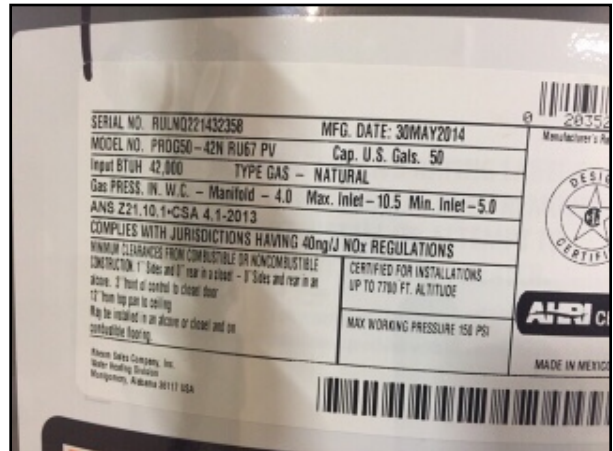
Water heater and data plate. Operates as expected.

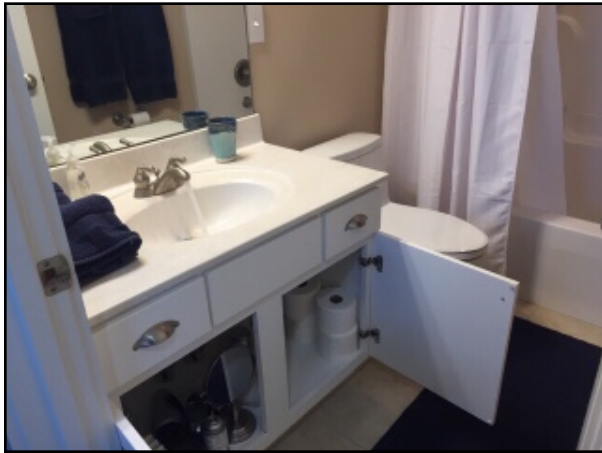
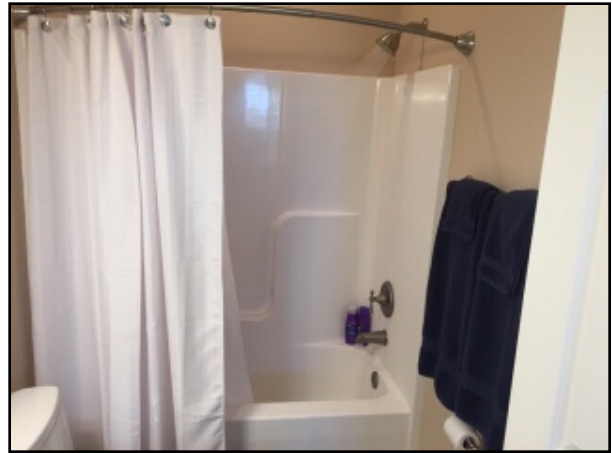
**Comment 21:**  
Hall bath fixtures operate as expected. Ok.

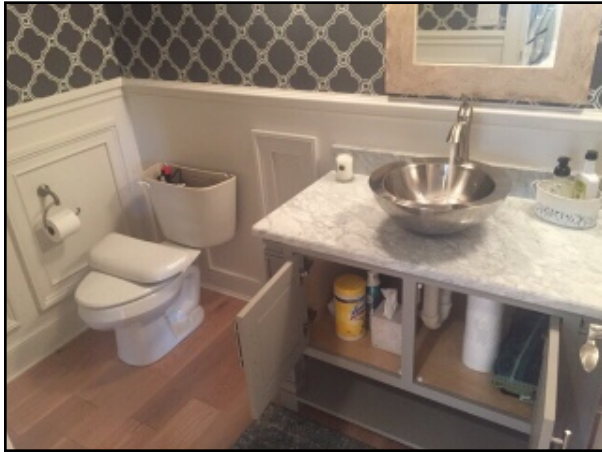
Figure 22-1

Half bath fixtures operate as expected. Ok.

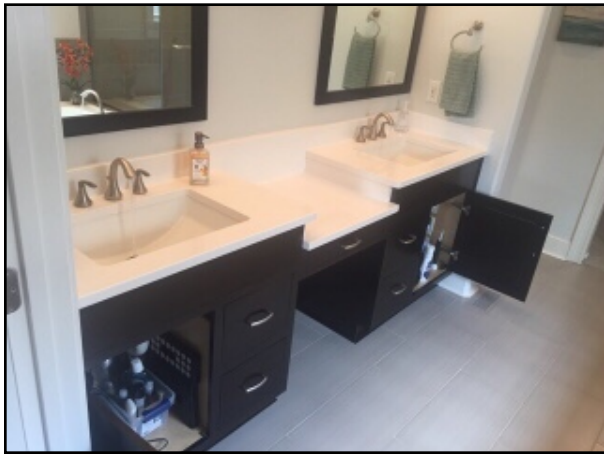
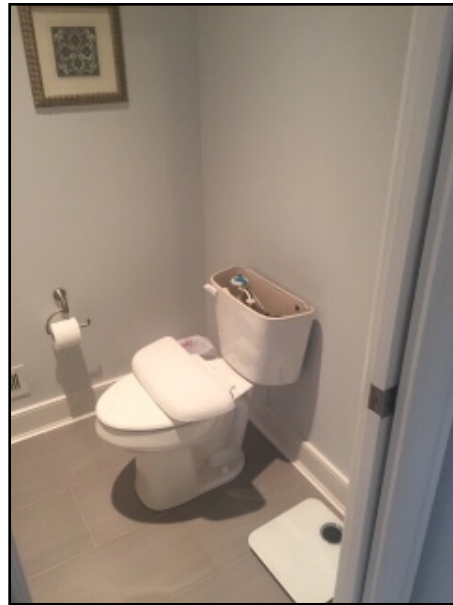
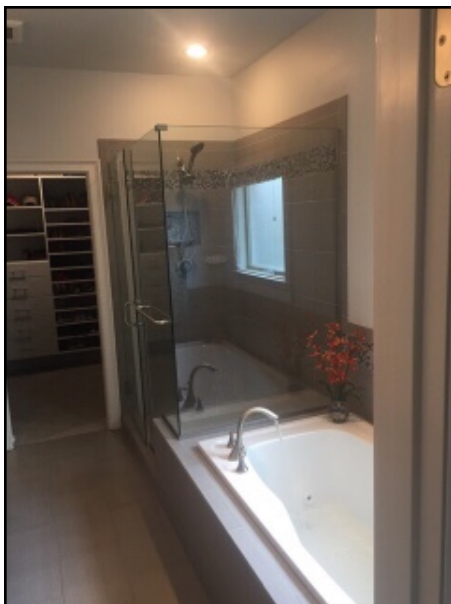
Master bath fixtures operate as expected. Ok.

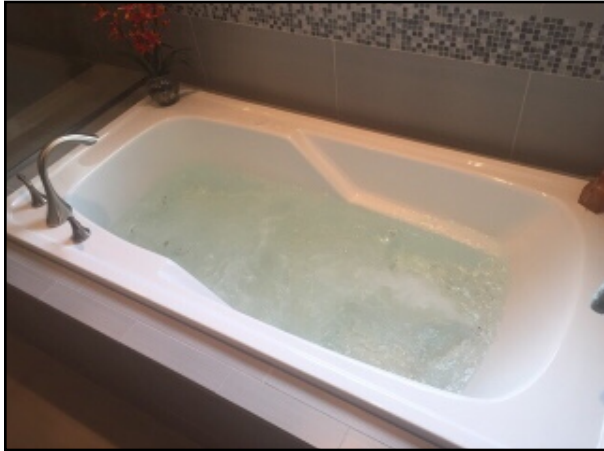
Figure 24-1

- i** Comment 24:  
Whirlpool tub operates as expected. Fill and run with 2 cups of bleach for 15 minutes to clean and then refill with plain water and run to rinse.

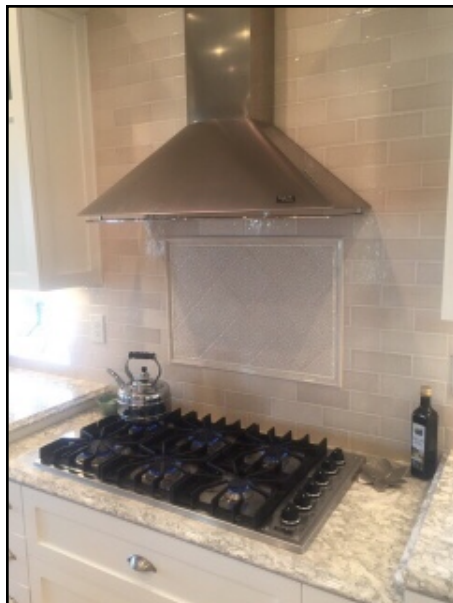
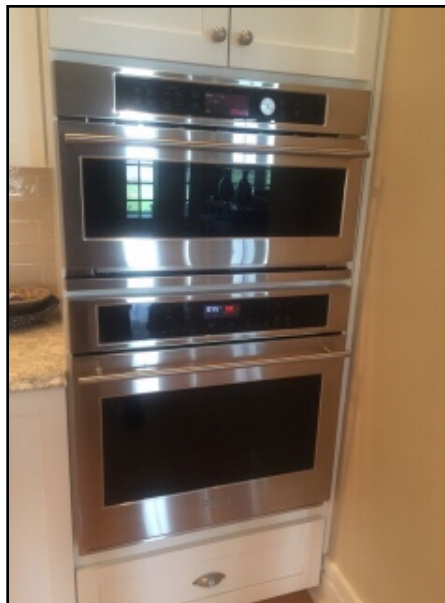
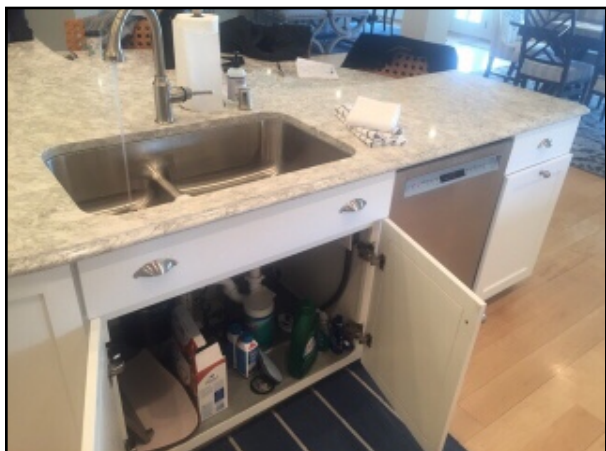
Appliances operate as expected except as otherwise noted. Ok.

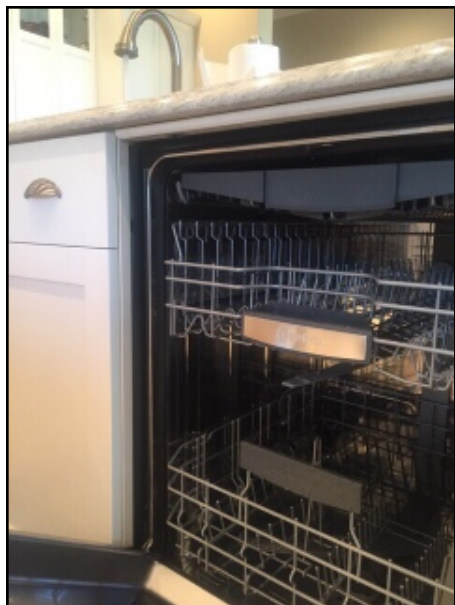
Figure 26-1

Dishwasher is not secured to counter. Have fully installed, leveled and operation verified before closing.

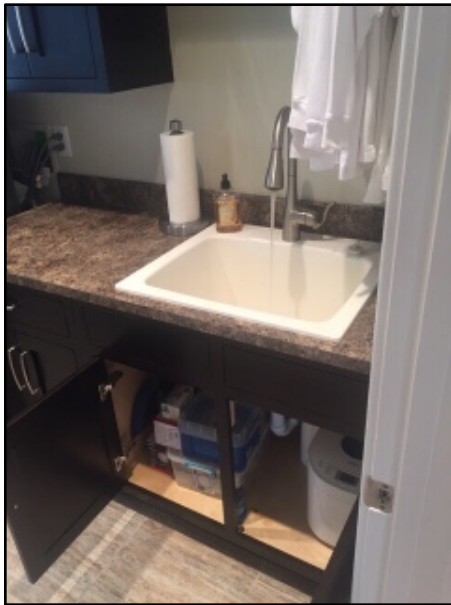
Figure 27-1

Comment 27:  
Laundry sink operates as expected.

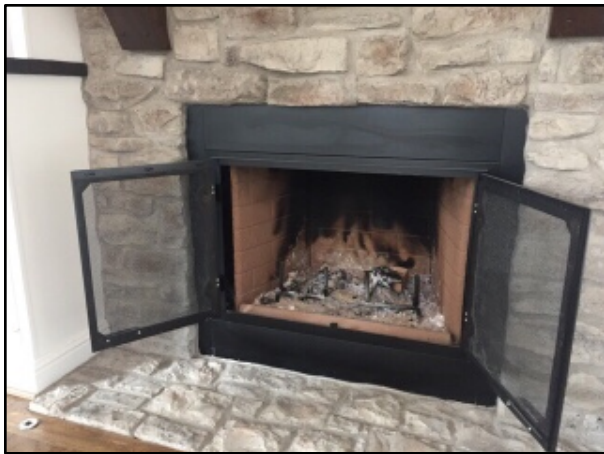
Figure 28-1

Wood burning fireplace is in acceptable condition. Ok. Have cleaned yearly by chimney sweep if used.

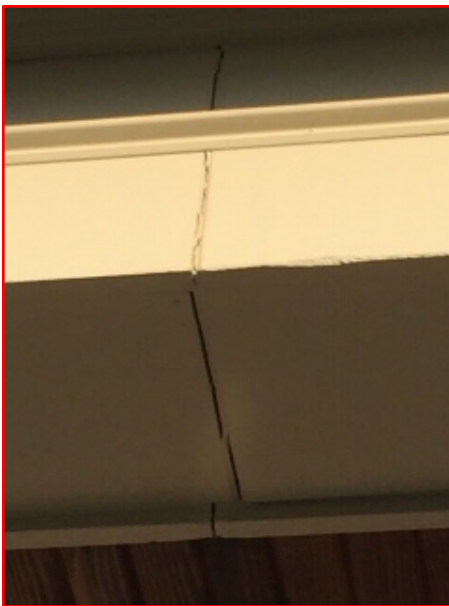
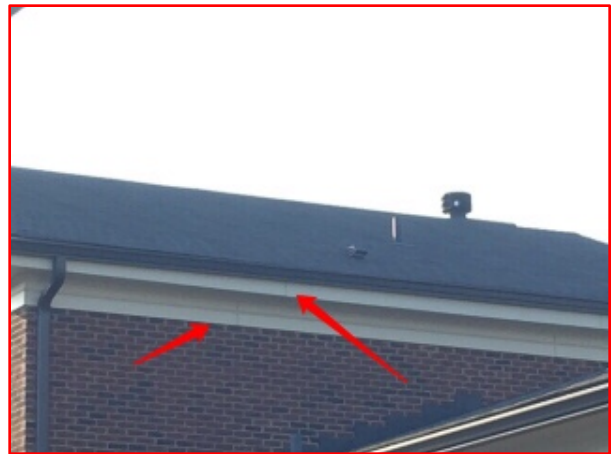
1) Several areas of gaps in exterior trim. Have caulked and painted to protect from weather.

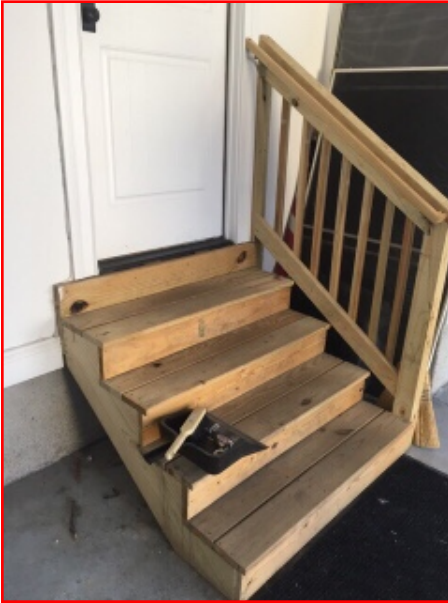
Figure 6-1

2) Steps in garage are missing handrail & guardrail. Install for safety.

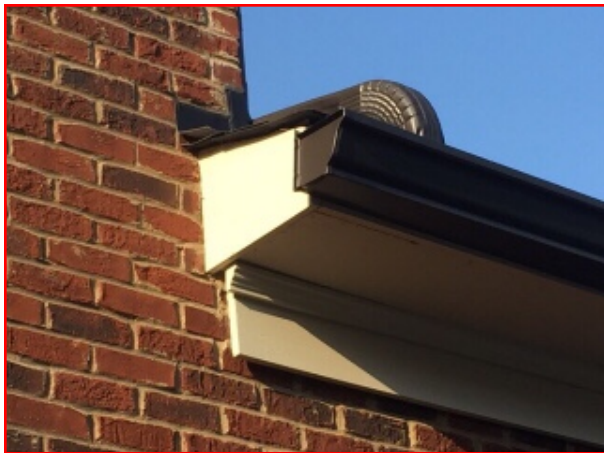
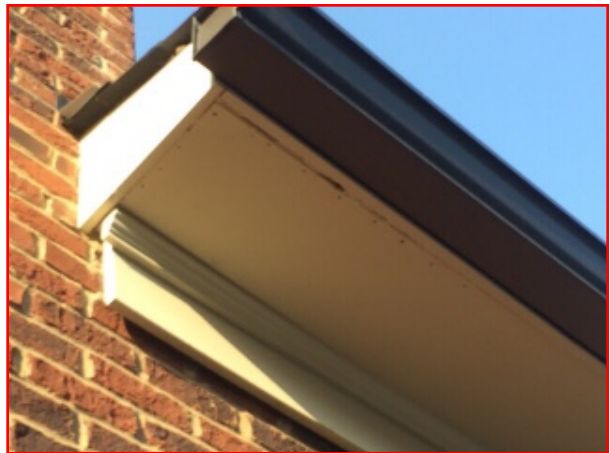
3) Prior repairs to rear right soffit. Have owner explain when and why repairs were made. Monitor.

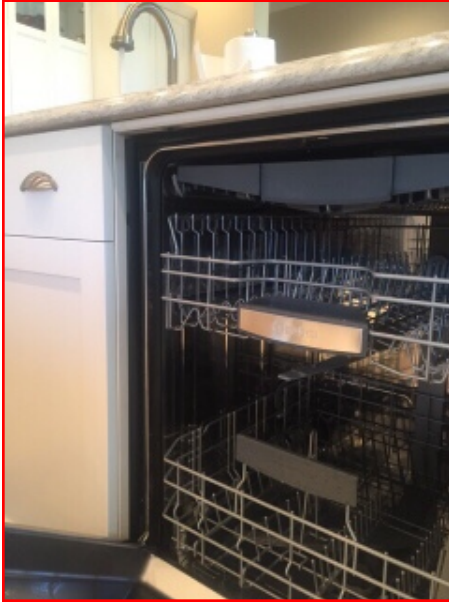
Figure 26-1

4) Dishwasher is not secured to counter. Have fully installed, leveled and operation verified before closing.
